Evaluation of *Rhizobium tropici*-derived Biopolymer for Erosion Control of Protective Berms

Field Study: Iowa Army Ammunition Plant

June 2016

Final report

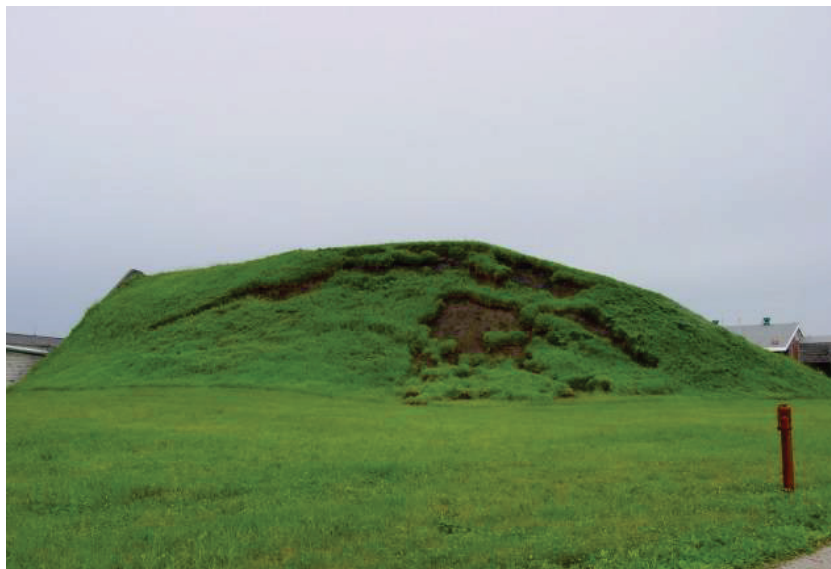
Figure 2-1. Berm 03-50-A at IAAAP, showing loss of height, slope degradation and land slips on the face of the berm.

The selected biopolymer test site was Berm 03-50-A at the IAAAP. Figure 2-1 shows the condition of the berm prior to the field demonstration. Berm erosion and a series of small landslides had caused progressive collapse of the berm face and loss of protective height. Darker areas with no vegetation indicate the recent propagation of numerous small landslides into and across the slope. These led to a number of conditions that made the berm unusable, including reduced blast protection (as a result of loss of berm height), which is unsafe for berm vegetation management (e.g., mowing), as well as the potential for damage to surrounding buildings, roads, and drainage features.

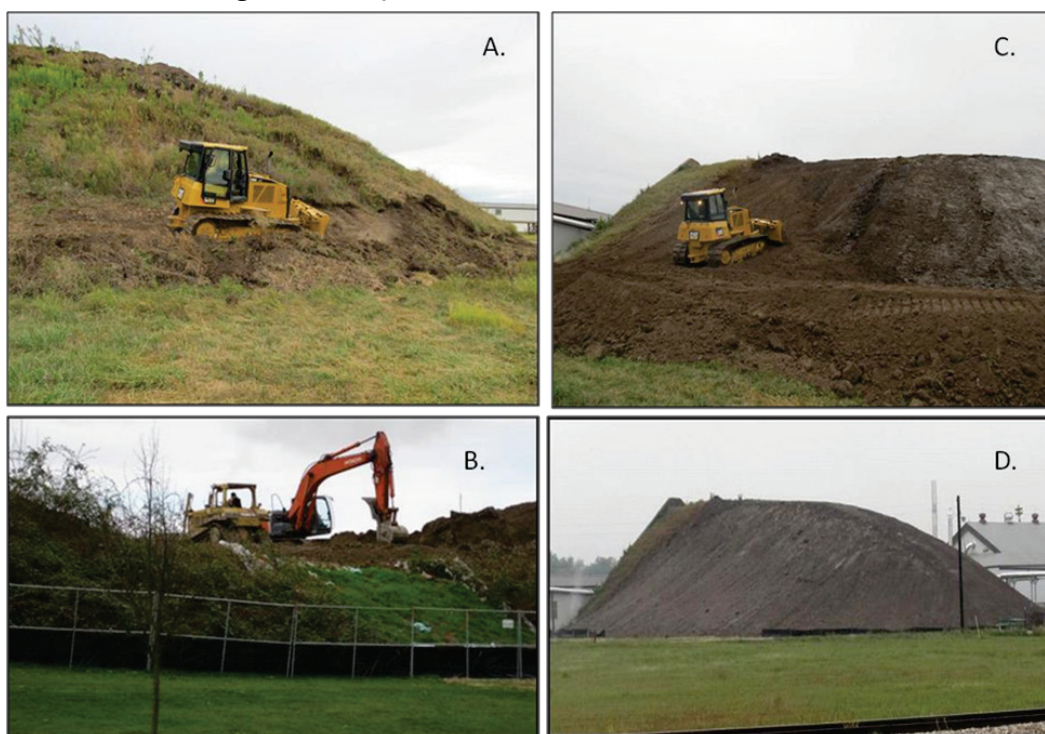
Figure 2-2. Steps in the reconstruction of Berm 03-50-A.

used to restructure the berm (Figure 2-2B and C). The completed berm is shown in Figure 2-2D. The silt fence, visible in Figure 2-2D, was used for containment until vegetation covered the berm face and reduced the potential for soil transport.

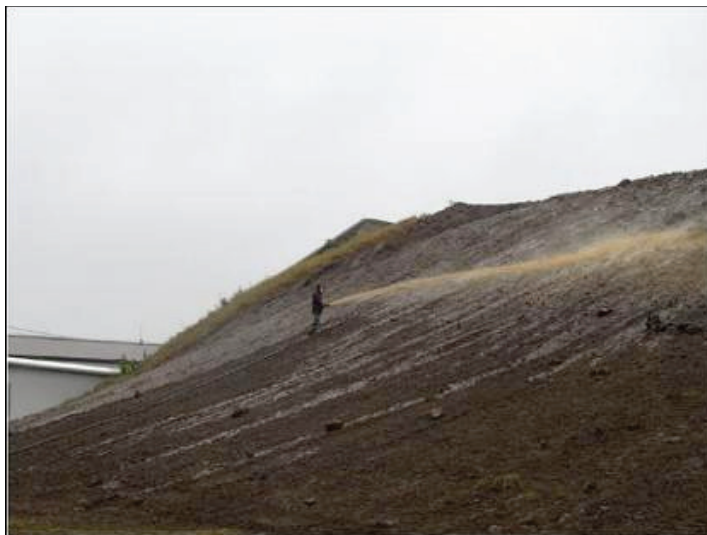
Figure 2-4. Application of biopolymer on the berm slopes.

The biopolymer was applied to the soil surface using a hydroseeder or a hand held water hose (Figure 2-4). The control area received only water and the same seed used on the experimental areas of the berm.

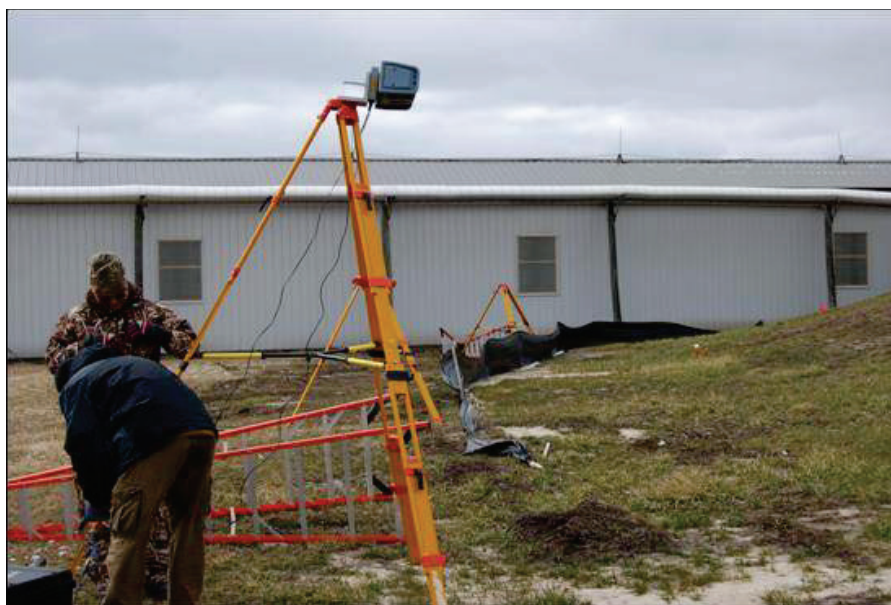
Figure 2-5. LiDAR team setting up the laser tripod one month post-treatment.

The team set up four concrete hubs approximately 24 inches deep in order to be below the freeze line. Survey markers were placed on top of the conduit pipe placed in each concrete-filled hole. These markers, along with a nail placed in the top-center of the berm wall, were used as the survey controls. This type of permanent control is used in order to have constant reference points, thus getting the highest accuracy possible between survey dates. Traditional surveying techniques were performed using a robotic total station coupled with RTK (Real Time Kinematic) grade GPS (Global Positioning System) survey measurements each time the berm was measured.

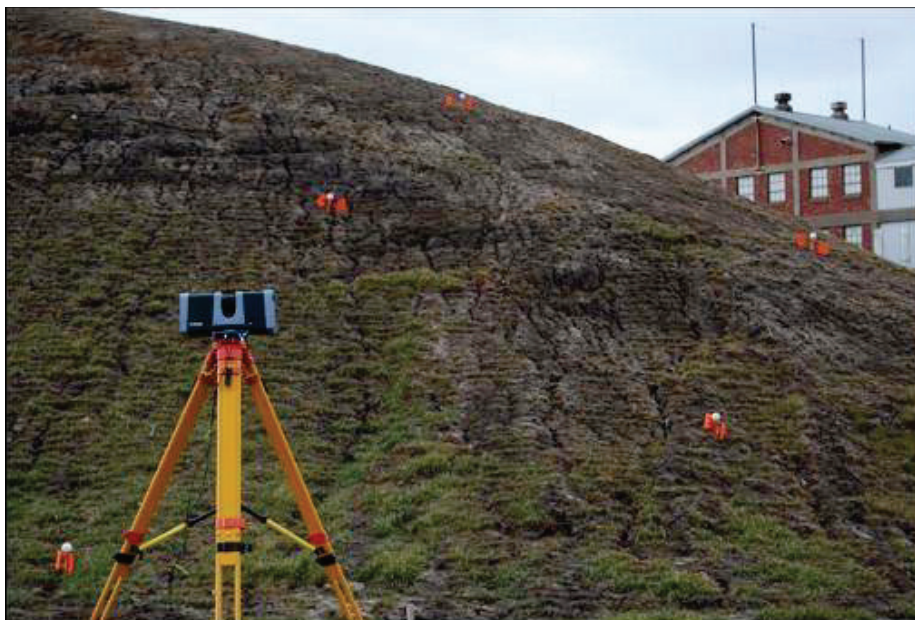
Figure 2-6. LiDAR registration spheres on the berm slope one month post-treatment with biopolymer and grass seed.

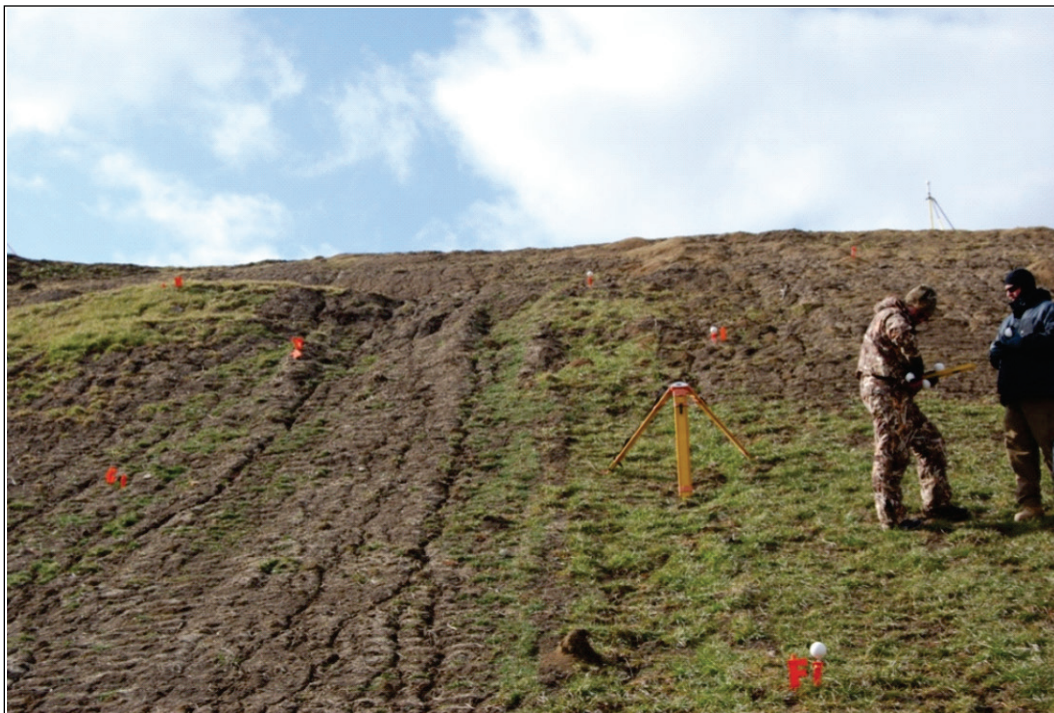
Figure 3-1. Comparison of surface rutting and vegetative growth after six months of weathering between the untreated control (Left) and the biopolymer-treated area (Right).

ETS, Inc. showed that the average biomass of the Fescue grass in the biopolymer treated areas increased 223% versus the control area, which was seeded with water but had no biopolymer. The ratio of root mass to the above ground plant mass was approximately 7% for the treated areas and 5% for the untreated soil. A photograph of the control next to a treated area illustrates the difference in grass growth at one month post-treatment (Figure 3-1).

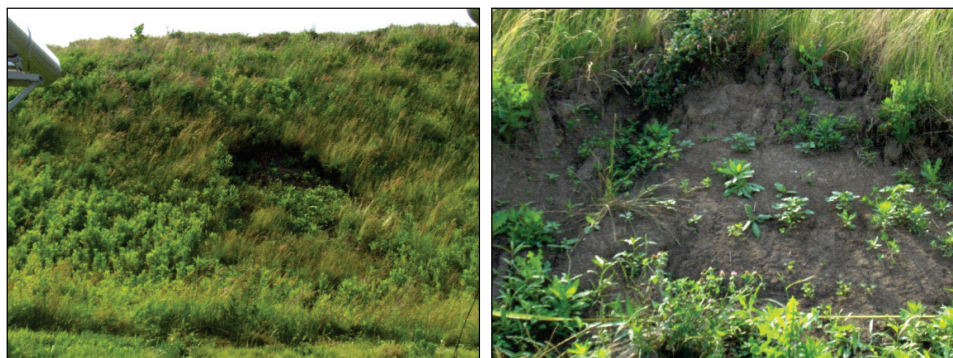
Figure 3-11. Photograph of the soil slip in Area C of the IAAAP explosion protection berm at 19 months post-treatment.

In May 2013, 19 months post-treatment, a small landslip was observed on the explosion protection berm in the area corresponding to Area C, the double surface application (Figure 3-10). The initial size of the collapse, was 11-ft wide by 25-ft long by 1-ft deep which yields a total displacement of 275 ft³ of soil (Figure 3-11).
